AEROSPACE VEHICLE PROTECTION  
from  
ATMOSPHERIC ELECTRICAL HAZARDS

**Quarterly Report No. 1**  
**Covering the Period**  
**January 1961 through March 1961**

**Lightning & Transients Research Institute**  
**Minneapolis, Minnesota**  
**L & T Report 384**  
**Contract No. AF 33(616) 7828**

## Airship Lightning Protection Braid Studies - II

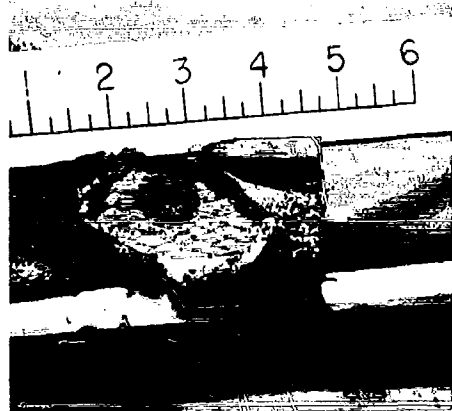
The 200 coulomb discharge to section II resulted in little damage. As shown in Figure 6 (c), a 3/4" hole was burned in the light tunnel fabric and the top of the asbestos wrap. The standard tunnel material or adhesive burned for about 3 seconds after the discharge. The arc did not burn completely through the stranded braid as shown in Figure 6 (d). The airship fabric was only slightly warm because the braid was held off the chafing strip by tucking the tunnel under the braid so that it did not contact the chafing strip as in section I. The 1/4" air space between the braid and the airship fabric reduced the local heat intensity transmitted to the airship fabric at the arc contact point. This is in contrast to the heating of the airship fabric on section I where the braid and fabric are held tightly together.

(d) Braid condition after 200 coulomb discharge.

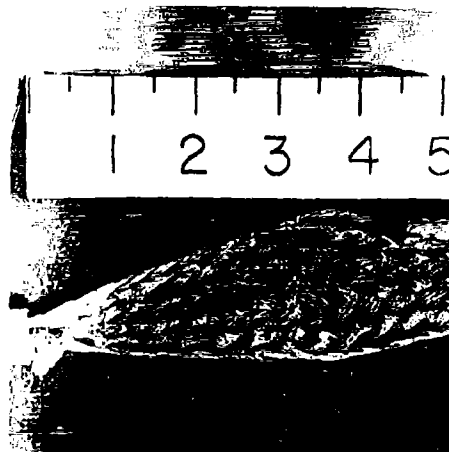
Figure 9. Strand breakage in braid from lightning currents.

The high current strokes did not cause the braid to pull out of the connector lugs at the braid ends as in tests reported earlier in LTRI Report No. 366. The double thickness of the braid in the lug hole along with compression stress reduces the possibility of the braid strands pinching and pulling out during a stroke. As shown in Figure 9, the braid did not pull out from the lug but some strands of braid were broken in an area 3" back from the lug. In Figure 9 the braid is shown expanded to reveal the section with broken strands.
